Comparison of Early Fatigue Failure of the TFNa and Gamma 3 Cephalomedullary Nails in the United States From 2015 to 2019

Matthew L. Klima, DO

(*J Orthop Trauma* 2021;35:e39–e44)

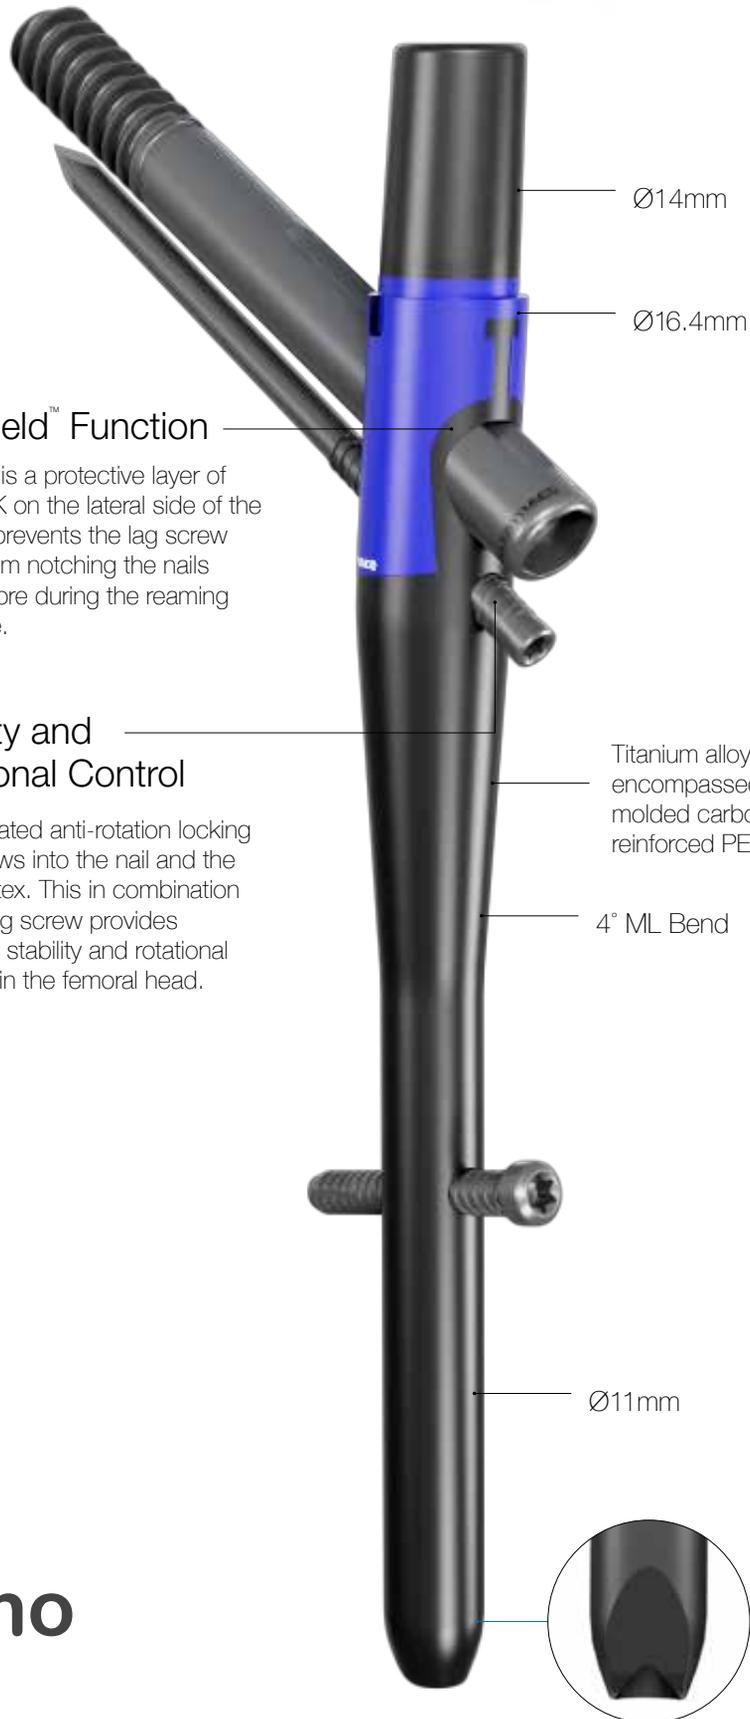
Lagshield™ Function

Lagshield is a protective layer of CFR PEEK on the lateral side of the nail. This prevents the lag screw reamer from notching the nail's titanium core during the reaming procedure.

Stability and Rotational Control

The integrated anti-rotation locking pin** screws into the nail and the lateral cortex. This in combination with the lag screw provides enhanced stability and rotational control*** in the femoral head.

Beveled nail tip design

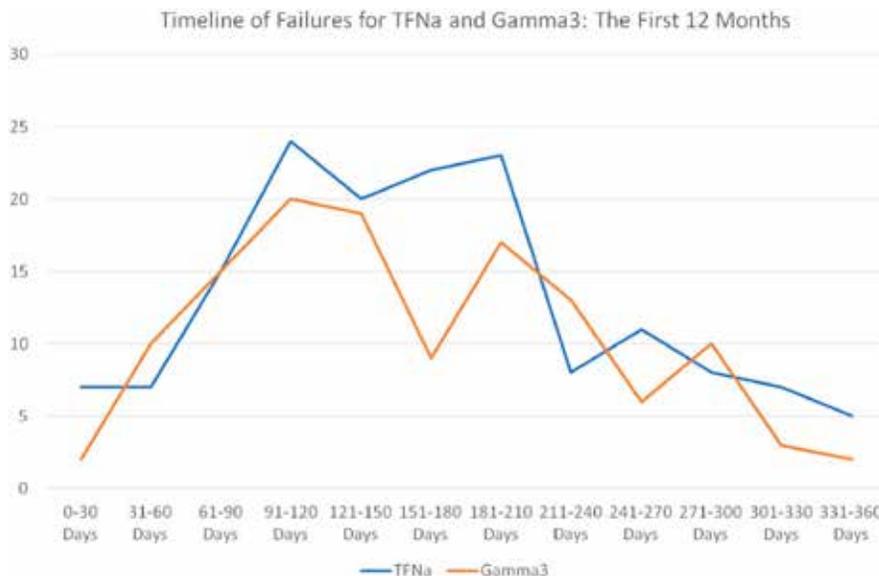
FIGURE 1. Time to failure for implants that failed plotted as the number of failures (y axis) found per time interval in days post-operatively (x axis). Depicted are only reported failures that occurred during the first 12 months post-implantation.

From January 2015 to October 2019, 2724 total MDRs were submitted to the FDA regarding Gamma 3 and TFNa (1651 and 978, respectively). TFNa comprised 350 reports coded “break” that included the implants, instrumentation, or implant components such as distal interlocking screw. Only 191 of 350 reports contained the date of implantation in the report. After the FDA provided individual 191 MDRs for the TFNa, 8 additional reports were removed by the investigator after being identified as duplicate or miscategorized, leaving 173 reports for analysis. Gamma 3 comprised 360 reports coded “break,” but only 170 were determined by the FDA to contain the date of implantation. Eleven additional reports were removed by the investigator after being identified as a duplicate or miscategorized for the Gamma 3 data set, resulting in 159 reports for analysis. For both implants, the 2 most common categories of reports were implant fatigue failure with 342 reports and femoral head cutout with 334 reports. All implant fractures occurred in the same location through the proximal screw aperture. Implant demographics and timeline of failures are outlined in Table 1 and Figure 1, respectively.

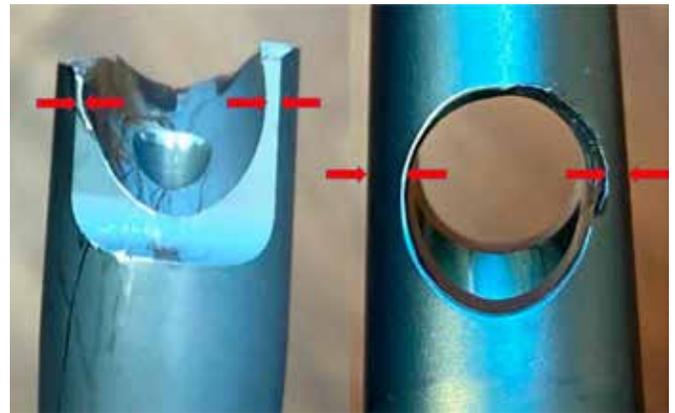
FIGURE 3. Pictured left: distal portion of fractured Gamma 3 implant looking at the lateral aspect of the proximal screw aperture. Arrows outline borders of implant walls in this region. Decrease in wall thickness on the left side of the aperture can be appreciated by comparing the distance between the opposing arrows. A large notch contributed to fatigue failure at 5 months. Other factors contributing to fatigue in this case were delayed union of subtrochanteric femur fracture and BMI >40. Pictured right: differences in lateral implant wall thickness of the proximal screw aperture of a notched TFNa are marked by arrows. All 342 failed implants fractured in proximity to this area.

formation, secondary fracture lines could extend distally below the proximal screw aperture into the thinner lateral wall because of the poor stress distribution and alloy

properties described.^{21,33,34} This break pattern and location correlates with the atypical failures of the TFNa observed by Lambers et al with additional implant fragments and cracks noted surrounding the point of failure along the proximal screw aperture. Typical fatigue failure of cephalomedullary implants results in the formation of 2 implant pieces, and therefore, secondary fragmentation of the implant at the point of failure would be unusual.^{16,21,28,29,35} Descriptions of this secondary fragmentation of the TFNa at the point of failure were noted in the manufacturer’s inspection reports available in the MAUDE data pool as well. Formal finite element analysis to quantify the changes in structure and their potential impact on fatigue failure would be required to adequately describe the differences observed.

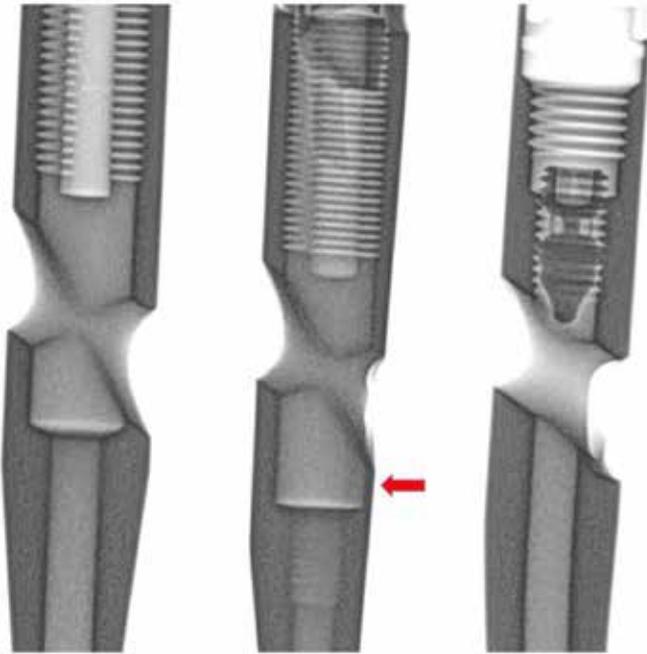
FIGURE 4. X-ray of 12 mm TFN, 10 mm TFNa, and 10 mm Gamma 3 implants from left to right. Single arrow identifies the lateral wall of TFNa implant just inferior to the proximal screw aperture in a region of sharp transition in wall thickness that is new compared with previous design of TFN. Wall thickness in this key region seems to be narrowest in the TFNa partially because of the design of the “lateral relief cut,” which not only decreases proximal implant circumference but results in a markedly thinner implant wall laterally compared with the opposite wall medially. It is important to note that the tensile forces subjected to the implant during bending are highest in this same region. In the Gamma 3 implant of equivalent size pictured on the far right, there seems to be minimal difference in medial/lateral wall thickness in this region.

There have been several changes in the design of the proximal TFNa and Gamma 3 implants which could account for some of the key findings in our study. The weakest portion of the cephalomedullary nail is at the proximal screw aperture where the implant’s cross-sectional area is reduced by almost 75 percent.²⁹ This key region was made even thinner in both the Gamma 3 and TFNa with reduced proximal diameters from 17 to 15.5 and 15.66 mm, respectively. Further reduction in the proximal diameter, in some cases down to 13.4 mm, is noted in the TFNa because of the design of the “lateral relief cut.” The effect of the lateral relief cut on the implant wall surrounding the proximal screw aperture is best demonstrated radiographically. Radiographic survey of the Gamma 3, TFN, and TFNa does reveal an additional key change in lateral wall thickness of the TFNa that could theoretically result in increased implant failures (Fig. 4) Identified in Figure 4 is an area of sharp transition in the thickness of the lateral wall distal to the proximal screw aperture. Compared with both TFN and Gamma 3 implants, the TFNa lateral wall thickness is markedly thinner in this region. Furthermore, the threads on the implant in the cannulation below the proximal screw aperture would contribute to poor stress distribution on the region of the nail that is subjected to the highest tension forces.^{17,30–33} The novel Ti-15Mo (TiMo) titanium alloy used in the TFNa has a lower tensile strength in smooth tensile testing compared with the Ti-6Al-4v (TAV) titanium alloy found in other cephalomedullary nails.³⁴ Simply stated, an implant with a thinner lateral wall subjected to tension forces made of an alloy with a lower smooth tensile strength would likely fail faster.
